Test Report

No. CANML1721954801

The following sample(s) was/were submitted and identified on behalf of the clients as :
ASA synthetic resin roof tile (spanish style roof tile)

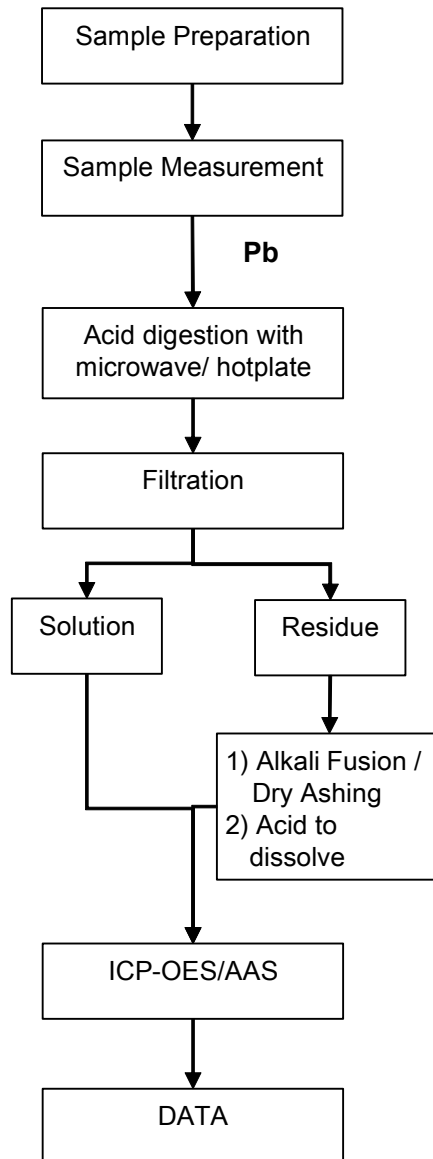
Pb Testing Flow Chart

- 1) Name of the person who made testing: Edith Zhang
- 2) Name of the person in charge of testing: Bella Wang
- 3) These samples were dissolved totally by pre-conditioning method according to below flow chart.
